Figure 1: View of the area where the earthen dam failed

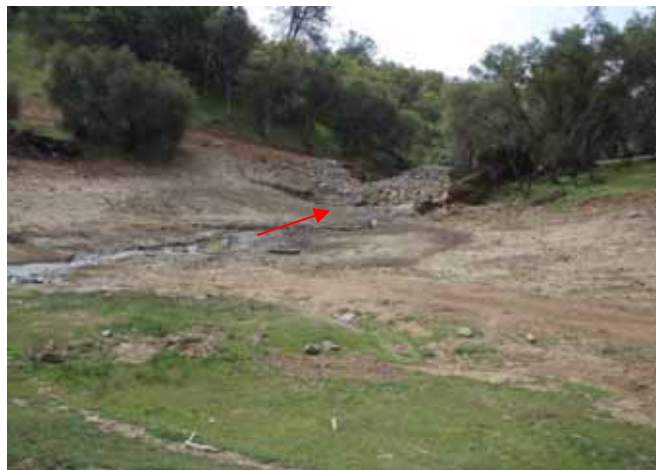
Figure 2: View of the former pond area Note: view is looking down stream towards the area where the earthen dam failed

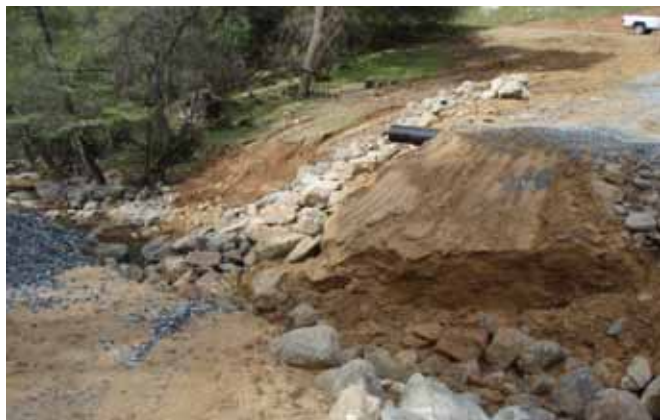
Figure 3: Area where the earthen dam failed

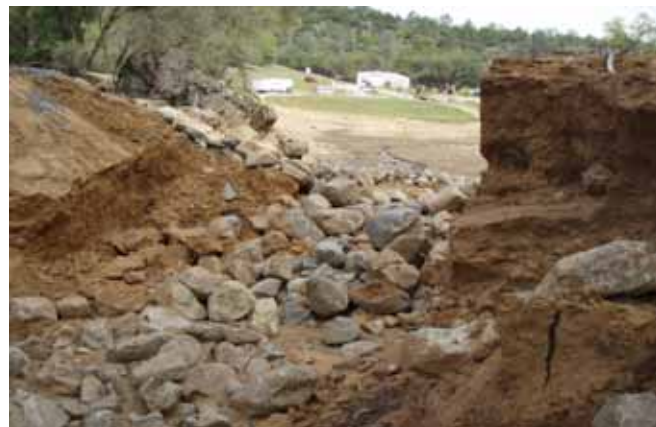
Figure 4: Another view of the dam failure area

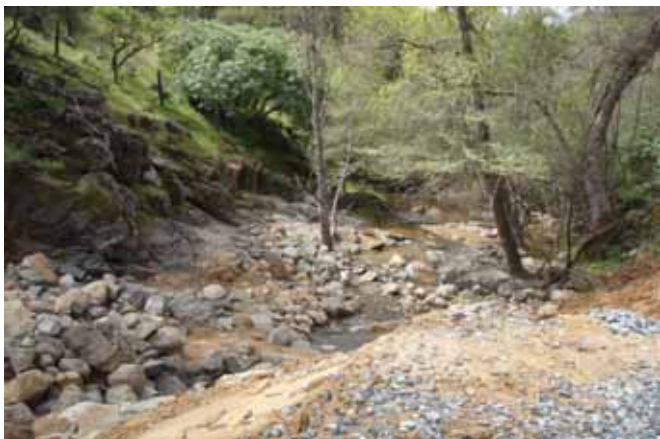
Figure 5: View looking immediately downstream from the dam failure area

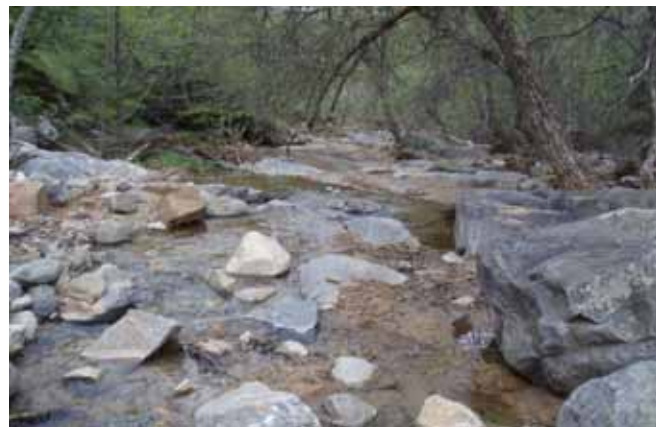
Figure 6: Sediment deposited in the stream channel just downstream of the dam

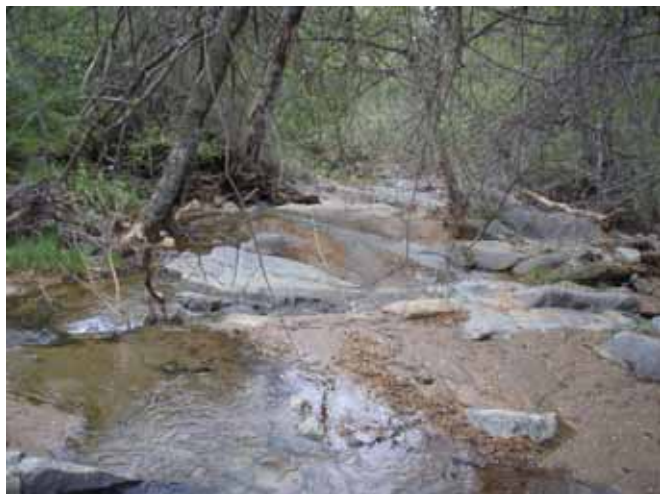
Figure 7: Sediment deposited further downstream

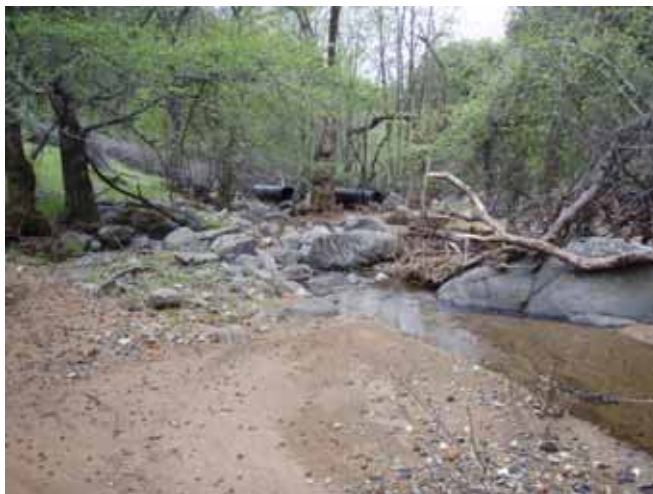
Figure 8: Sediment deposited still further downstream

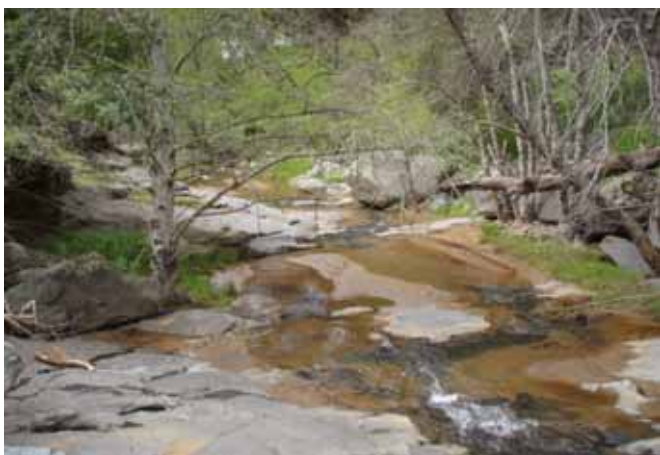
Figure 9: Sediment deposited even further downstream

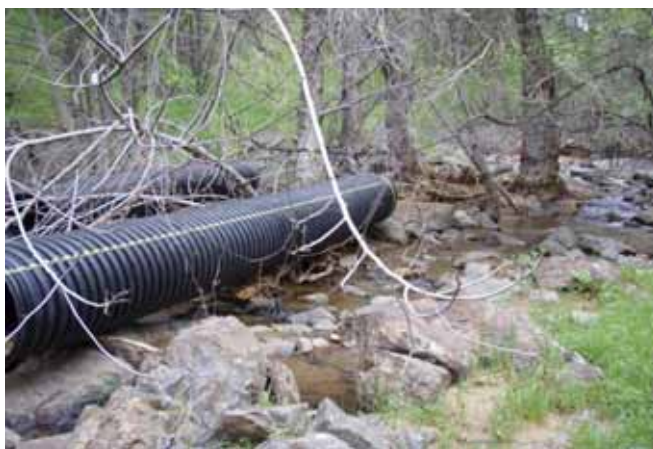
Figure 10: Culverts which washed down stream from the dam failure area

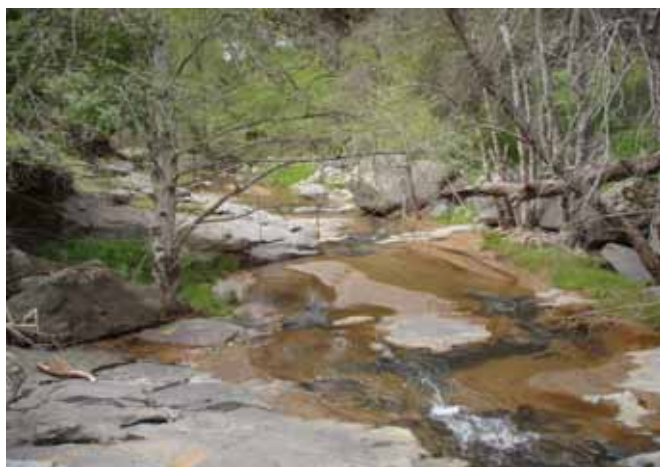
Figure 11: Sediment deposited still further downstream

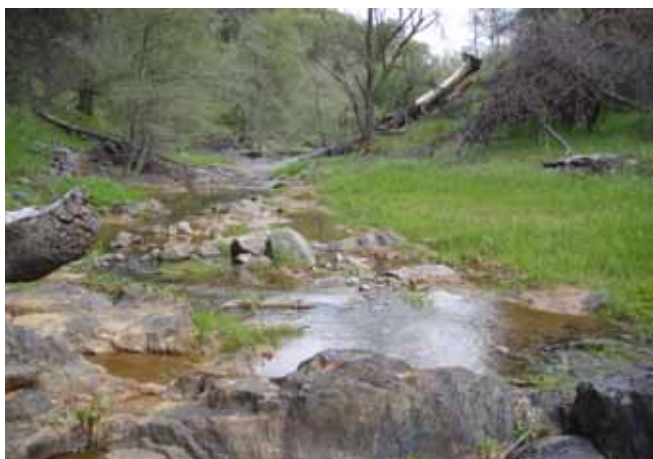
Figure 12: Sediment deposited approximately 1/4 mile downstream from the dam failure area
